Test report

InnoBYG small scale demonstration tests - Part 1

File	FUN0001
Serial No.:	1
Ref.:	TDJ/AND
Pages:	18

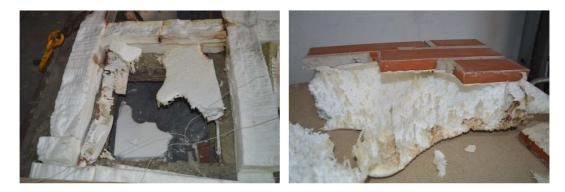
Test specimen	Observation
1	The glue has detached and some of the bricks had fallen down. This could have happened just before the end of the test, as indicated by the temperature meas- urements.

The EPS insulation has shrunk and melted in a large area in the middle of the test specimen. The insulation has melted and has formed stalactites.

Light brown discolouration of the remaining insulation.

The backing board is otherwise unaffected, which suggest that the insulation has not burned.

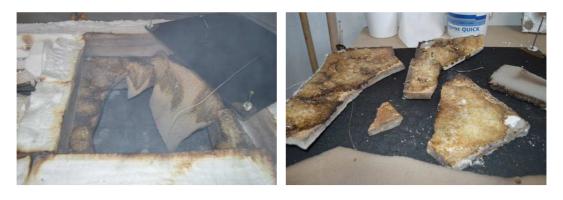
2

Parts of the rendering had fallen down during the test (after approx. 5 minutes), as indicated by the temperature measurements.

The EPS insulation had burned and is completely gone in a large area. Remains of melted insulation on the back side of the remaining part of the rendering.

The backing board (chipboard) is charred due to direct exposure (flames in the cavity behind the covering).

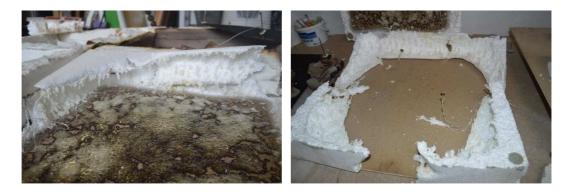
3

The plaster is intact as a solid board, held together by the reinforcement mesh.

The EPS insulation has melted in a large area, except along the outer edges of the test specimen. Melted remains of the insulation on the back side of the plaster.

The backing board is otherwise unaffected, which suggest that the insulation has not burned.

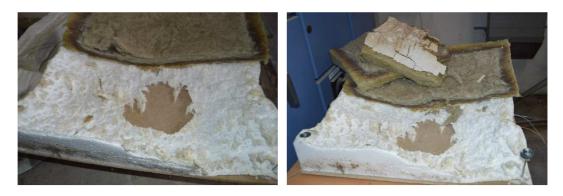
4 The glue has detached on one part of the stone wool insulation, but the other part is still attached to the EPS insulation.

The EPS insulation has melted and shrunk. Lumps of melted EPS insulation on the back side of the glue layer.

The backing board is otherwise unaffected, which suggest that the insulation has not burned.

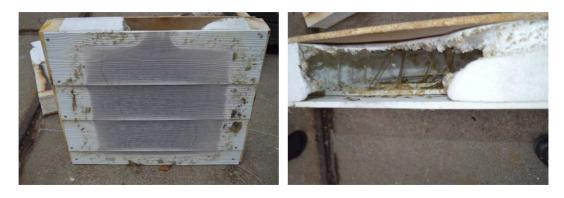
5

The fibre cement planks are still in place, but some transverse cracks have evolved. The planks bend outwards. One of the joints between the planks had opened.

The EPS insulation has almost completely melted away, but there are remains of melted insulation that looks like melted caramel.

The insulation has also melted in an area at the edge of the test specimen and small discolouration of the backing board suggests some influence by a neighbouring test specimen.

The backing board is otherwise unaffected, which suggest that the insulation has not burned.

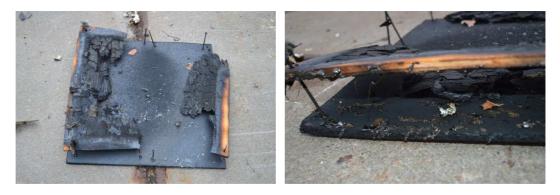
7 The plywood has burned through and only small parts of the plywood remains.

> The EPS insulation has completely burned away and only very small remains of melted insulation remains along the edges of the test specimen.

The backing board (chipboard) has significant charring which suggest direct exposure of the backing board.

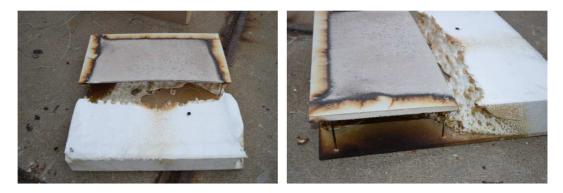
8

The gypsum plasterboards were still in place, but the joint between the boards had opened a bit. One of the boards was removed after the test in order to examine the insulation.

The EPS insulation had melted in an area along the joint. In the area away from the joint, only shrinking of the insulation had occurred.

The EPS insulation had melted away in an area at the edge of the test specimen and there was significant discolouration of the backing board at that edge. This suggests influence from a neighbouring test specimen.

The backing board is otherwise only weakly discoloured.

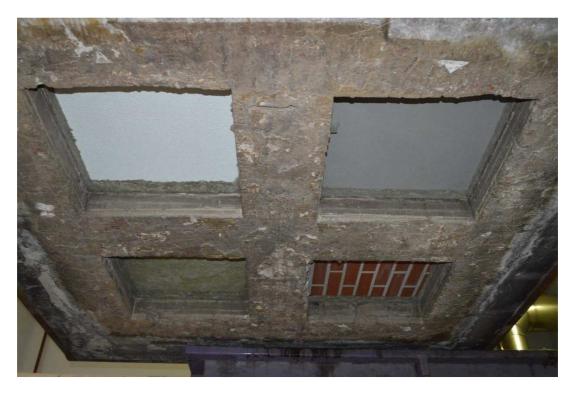
Photo No. 1 Test specimens no 1, 2, 3 and 4 from exposed side before test (test 1)

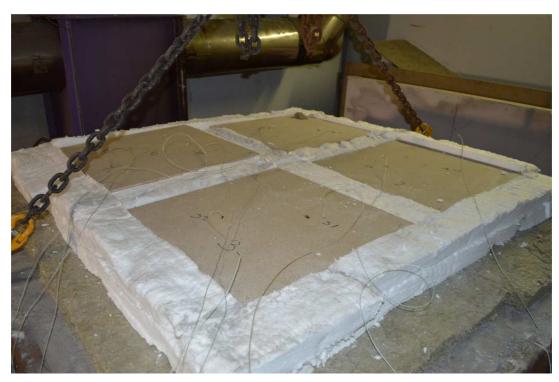
Photo No. 2 Test specimens no 1, 2, 3 and 4 seen from unexposed side before test

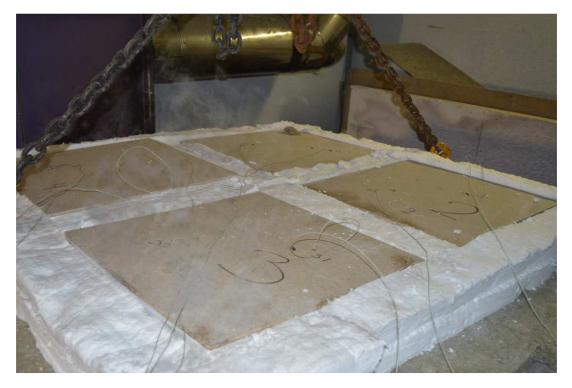
Photo No. 3 Test specimens no 1,2,3 and 4 after 6 minutes of testing

I COL II		
Time	Test	Observations
minutes	specimen	
0		Test start
3	2,3,4	Light smoke development
6	2, 3	Increasing smoke development, particularly from test specimen 2
10		Test stopped

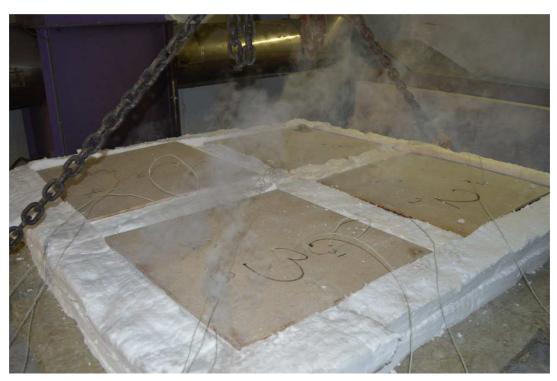
Photo No. 4 Test specimens no 1,2,3 and 4 after 7 minutes of testing

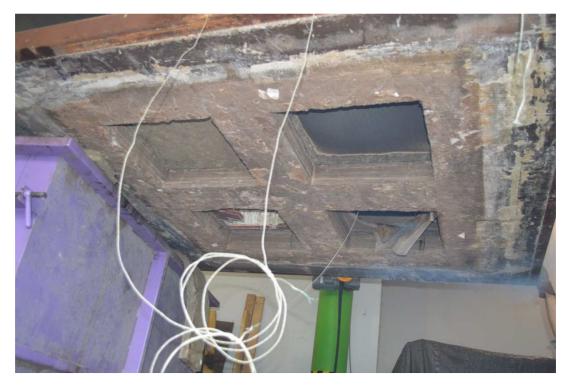
Photo No. 5 Test specimens no 1,2,3 and 4 from exposed side after the test

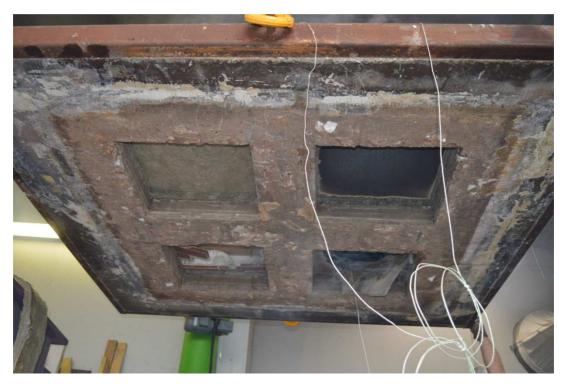
Photo No. 6 Test specimens no 1,2,3 and 4 from exposed side after the test

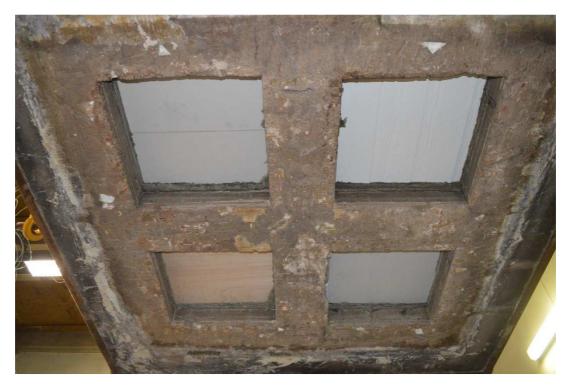
Photo No. 7 Test specimens no 5,6,7 and 8 from exposed side before the test (test 2)

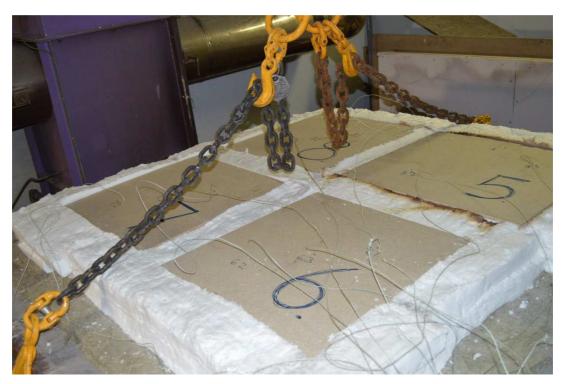
Photo No. 8 Test specimens no 5,6,7 and 8 from unexposed side before the test

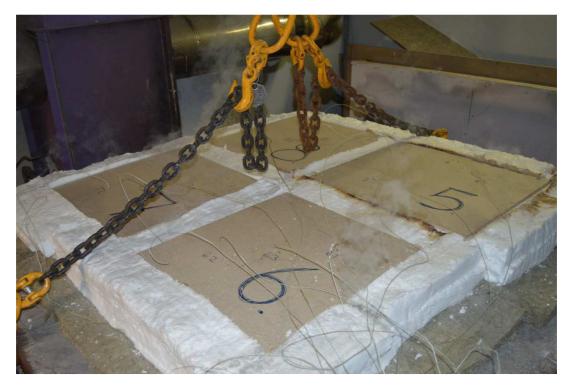
Photo No. 9 Test specimens no 5,6,7 and 8 after 3 minutes of testing

ICSU Z.		
Time	Test	Observations
minutes	specimen	
0		Test start
2	5,6,7,8	Light smoke development in general
4	5,6,7,8	Increased smoke development in general

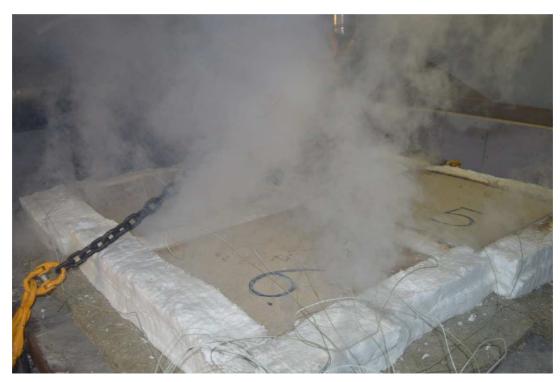
Photo No. 10 Test specimens no 5,6,7 and 8 after 7 minutes of testing

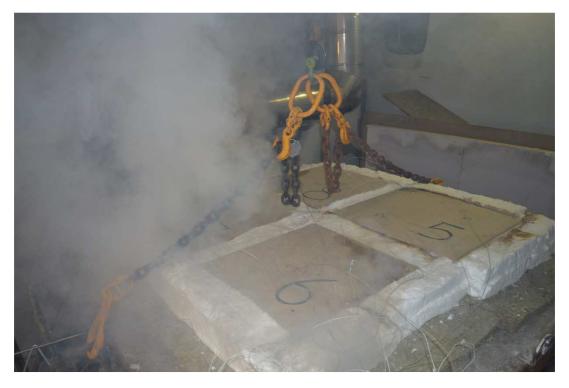
Photo No. 11 Test specimens no 5,6,7 and 8 after 9 minutes of testing

7	7	Significant smoke development
9	7	Spurts of flames from test specimen 7
10		Test stopped

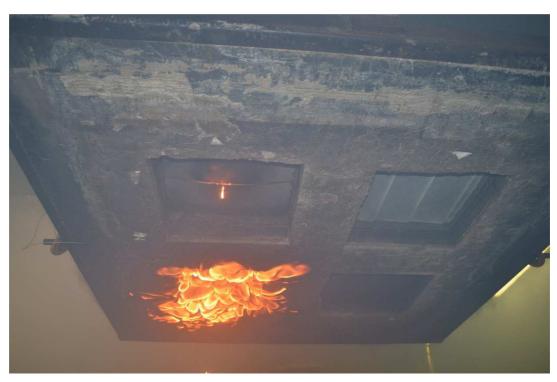
Photo No. 12 Test specimens no 5,6,7 and 8 after the test

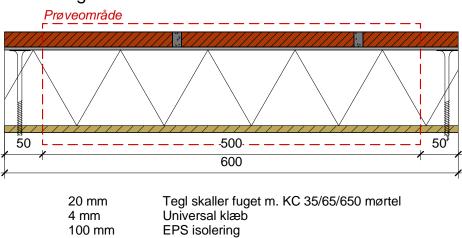
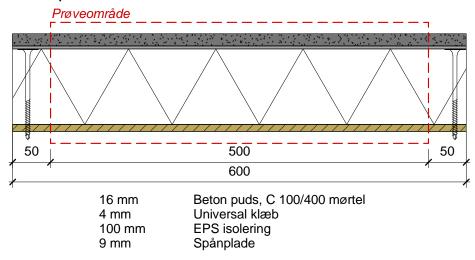
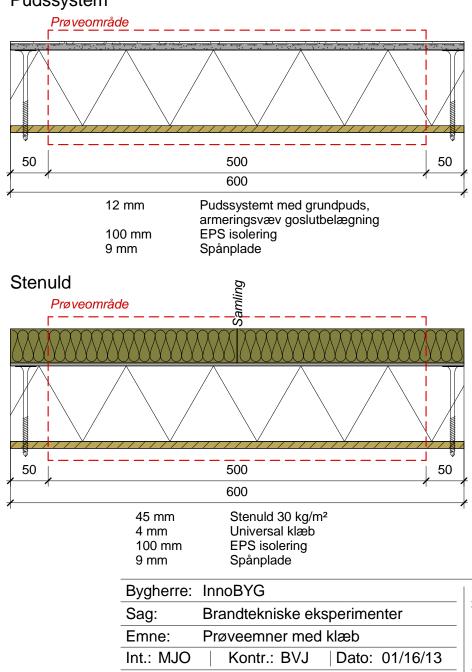
Tegn. nr.: A1.1

Prøveemner uden samling

Skærmtegl

Spånplade

Betonpuds

Pudssystem

Placering af thermoelementer 0 0

Type:	Enclosure:	Description:
Drawing	A1.1	Test specimens no 1, 2, 3 and 4
Drawing	A1.2	Test specimens no 5, 6, 7 and 8

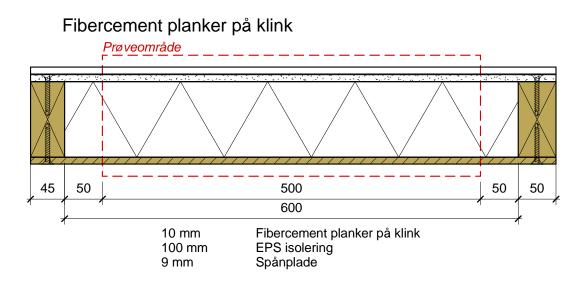
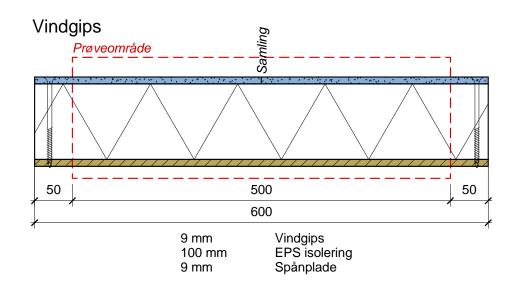
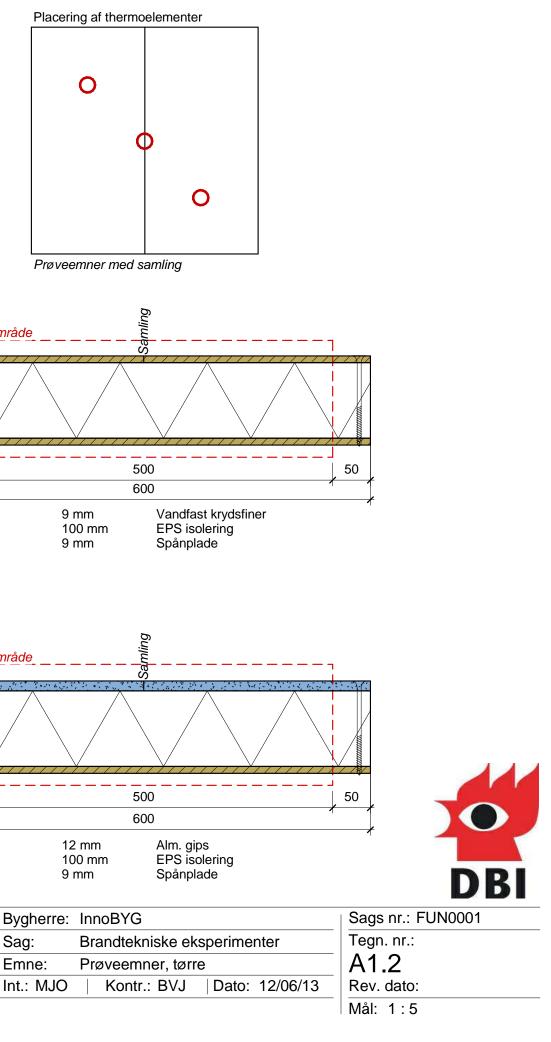
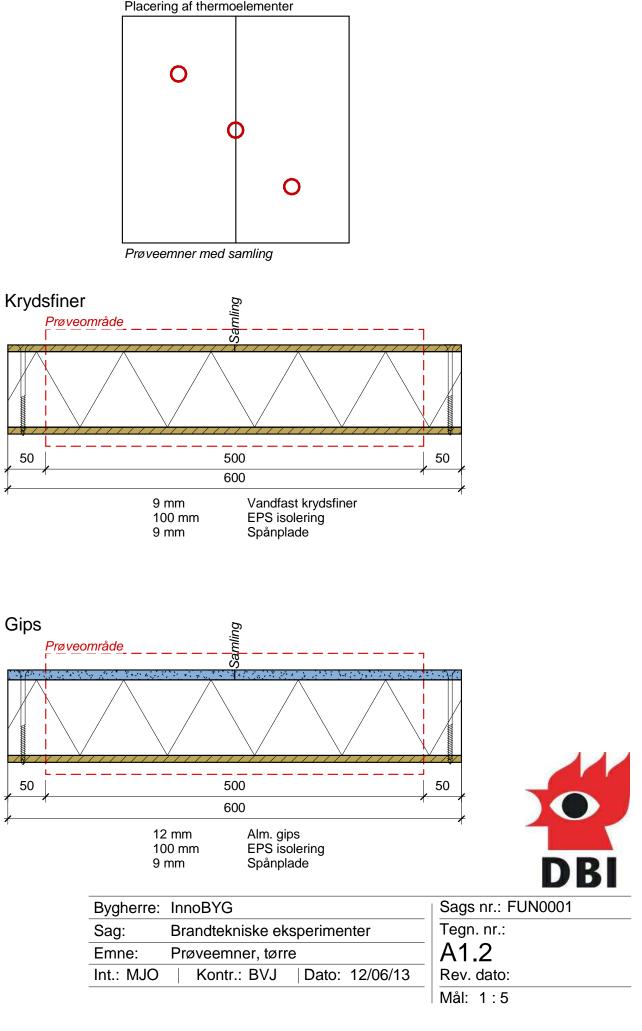
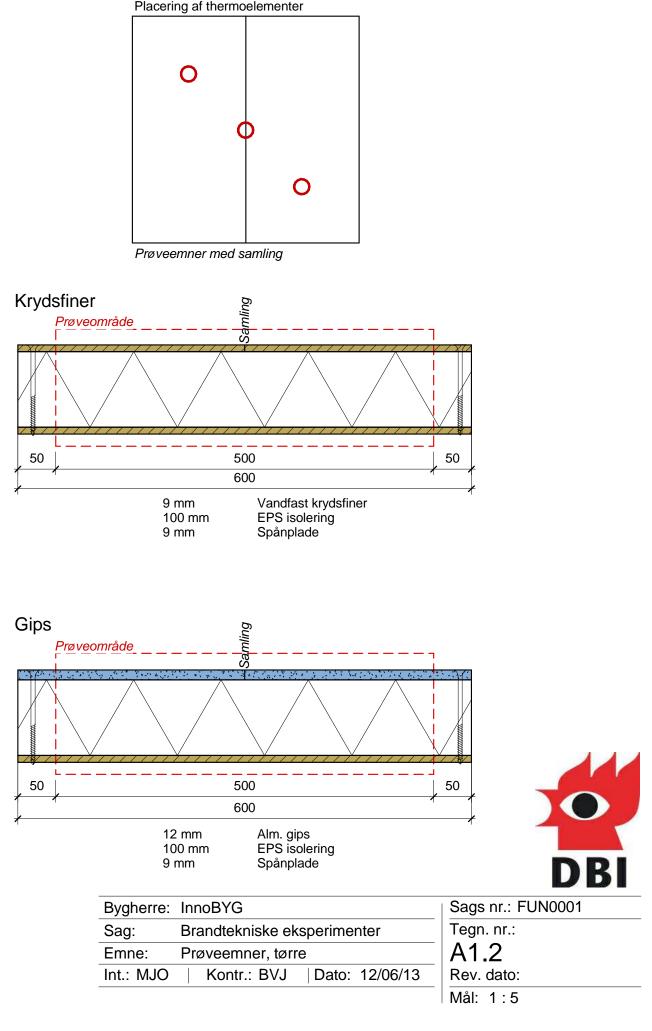
Tegn. nr.: A1.2

Prøveemner uden samling

Bygherre:	InnoBYG
Sag:	Brandtekniske ek
Emne:	Prøveemner, tørr
Int.: MJO	Kontr.: BVJ
Emne:	Prøveemner, tø

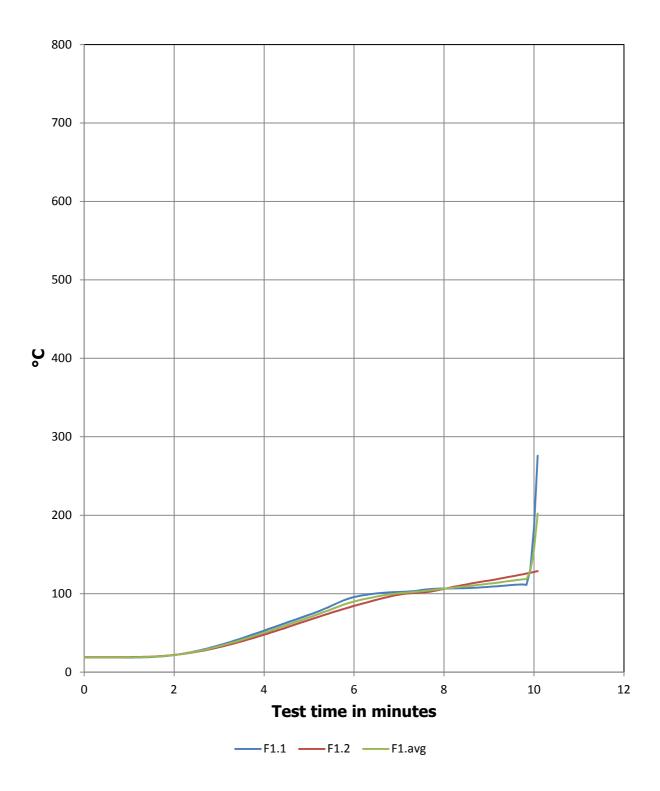
Min. / °C	F1.1	F1.2	F1.Avg
0.0	18.5	19.2	18.8
0.5	18.5	19.2	18.8
1.0	18.6	19.2	18.9
1.5	19.3	19.8	19.5
2.0	21.8	21.8	21.8
2.5	26.8	25.8	26.3
3.0	34.2	31.7	32.9
3.5	43.0	39.2	41.1
4.0	52.9	47.7	50.3
4.5	63.0	57.0	60.0
5.0	73.0	66.5	69.8
5.5	84.6	75.8	80.2
6.0	95.7	84.3	90.0
6.5	100.3	92.2	96.2
7.0	102.1	98.8	100.5
7.5	104.6	101.5	103.0
8.0	106.5	106.0	106.3
8.5	107.1	111.8	109.5
9.0	108.7	116.7	112.7
9.5	111.0	122.0	116.5
10.0	183.9	127.7	155.8

Enclosures 1.0 and 1.1 Temperature rise on test specimen 1.

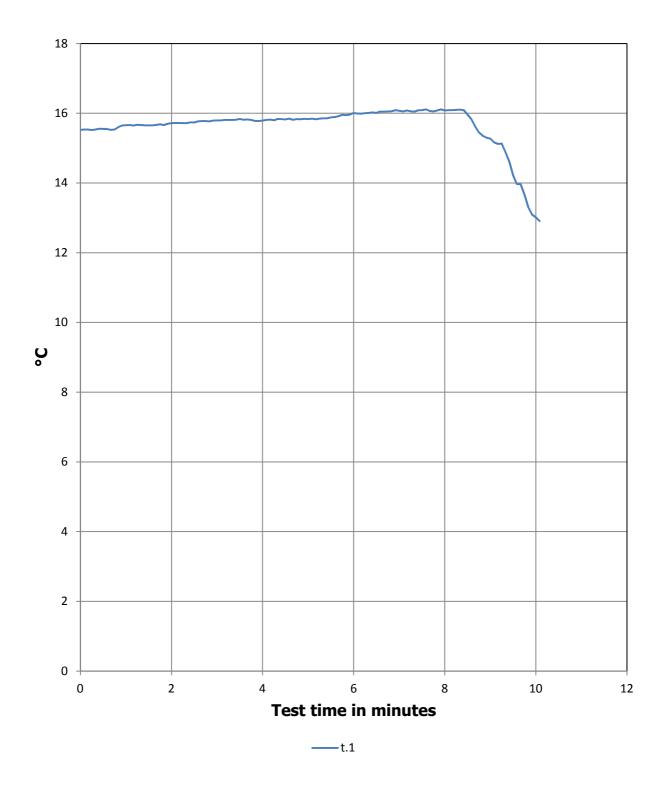
Ambient temperature (test 1)

Min. / °C	t.1
0.0	15.5
0.5	15.6
1.0	15.7
1.5	15.7
2.0	15.7
2.5	15.7
3.0	15.8
3.5	15.8
4.0	15.8
4.5	15.8
5.0	15.8
5.5	15.9
6.0	16.0
6.5	16.0
7.0	16.1
7.5	16.1
8.0	16.1
8.5	16.0
9.0	15.3
9.5	14.2
10.0	13.0

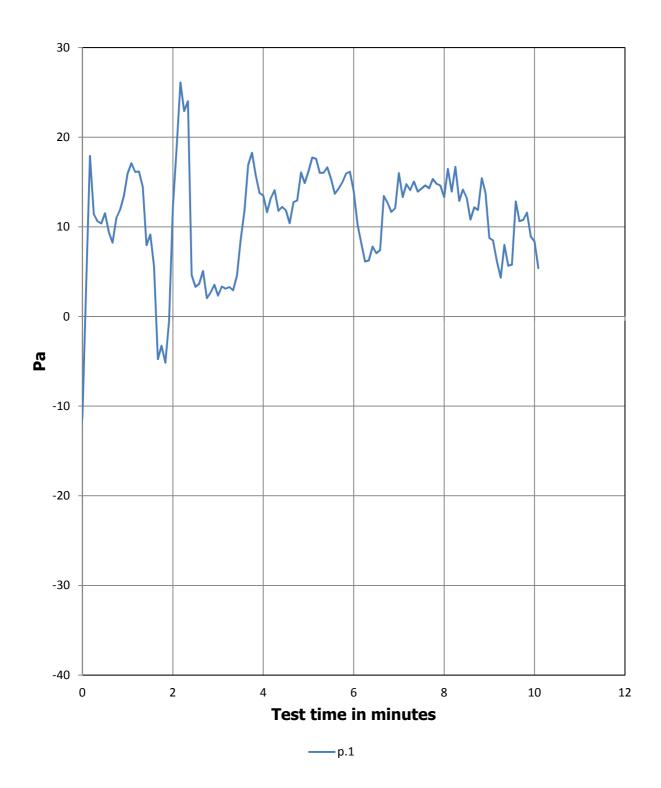
Furnace pressure (test 1)

Min. / Pa	p.1
0.0	-11.2
0.5	11.5
1.0	15.9
1.5	9.1
2.0	12.3
2.5	3.3
3.0	2.3
3.5	8.5
4.0	13.5
4.5	11.8
5.0	16.2
5.5	15.3
6.0	14.0
6.5	7.1
7.0	16.0
7.5	14.3
8.0	13.3
8.5	13.2
9.0	8.8
9.5	5.8
10.0	8.4

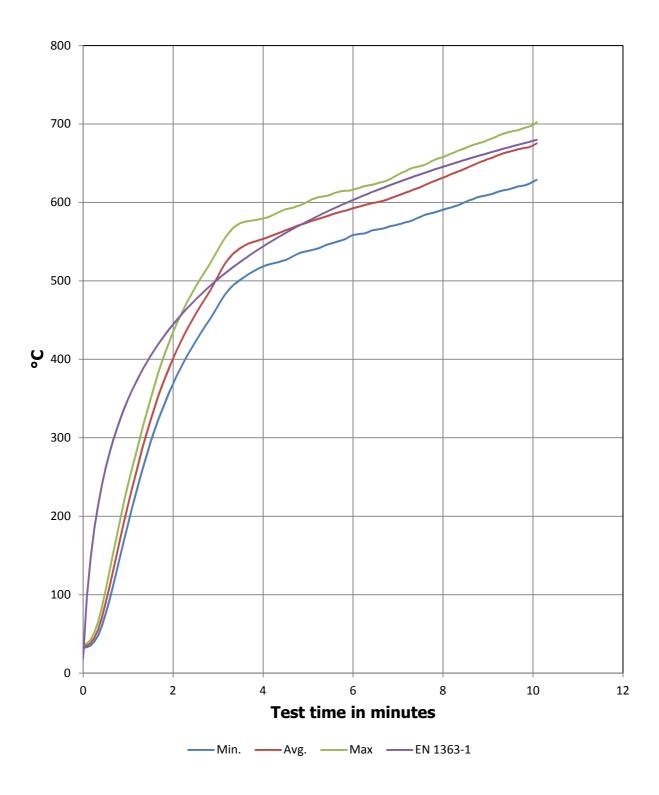
Furnace temperature (test 2)

Time	Measured			Norm	Area unde	r curve		
Minutes	Minimum	Average	Maximum	EN 1363-1	Measured	EN 1363-1	Dev. [%]	Limit [%]
0.0	32.1	33.9	35.6	20.0	0	0	#DIV/0!

0.5	75.2	89.0	105.3	261.1	26	85	-70.0	
1.0	190.4	215.0	241.1	349.2	102	240	-57.7	
1.5	294.6	322.4	349.2	404.3	237	429	-44.8	
2.0	368.8	401.1	434.9	444.5	419	642	-34.7

2.5	422.7	457.6	492.7	476.2	634	872	-27.3	
3.0	468.6	506.3	540.3	502.3	875	1117	-21.7	
3.5	501.6	542.1	573.9	524.5	1139	1374	-17.1	
4.0	518.4	553.6	579.6	543.9	1413	1641	-13.9

4.5	526.6	564.4	591.1	561.0	1692	1917	-11.7	
5.0	538.2	574.7	601.1	576.4	1977	2202	-10.2	
5.5	547.3	584.0	609.8	590.4	2267	2494	-9.1	15.0
6.0	558.5	592.5	616.2	603.1	2561	2792	-8.3	15.0

6.5	565.1	599.8	623.7	614.9	2859	3096	-7.7	15.0
7.0	571.8	608.8	635.3	625.8	3161	3407	-7.2	15.0
7.5	581.6	619.6	646.4	635.9	3468	3722	-6.8	15.0
8.0	590.5	631.3	657.8	645.5	3781	4042	-6.5	15.0

8.5	600.7	643.2	669.4	654.4	4100	4367	-6.1	15.0
9.0	609.5	655.2	679.4	662.8	4425	4697	-5.8	15.0
9.5	617.3	665.1	690.2	670.8	4755	5030	-5.5	15.0
10.0	626.2	672.4	698.5	678.4	5089	5368	-5.2	15.0

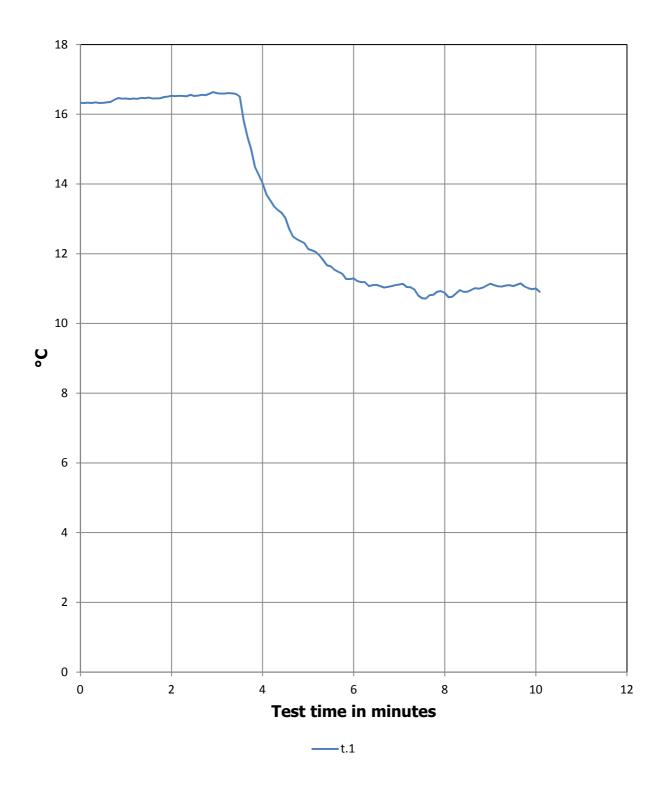
Ambient temperature (test 2)

Min. / °C	t.1
0.0	16.3
0.5	16.3
1.0	16.5
1.5	16.5
2.0	16.5
2.5	16.5
3.0	16.6
3.5	16.5
4.0	14.0
4.5	13.0
5.0	12.1
5.5	11.6
6.0	11.3
6.5	11.1
7.0	11.1
7.5	10.7
8.0	10.9
8.5	10.9
9.0	11.1
9.5	11.1
10.0	11.0

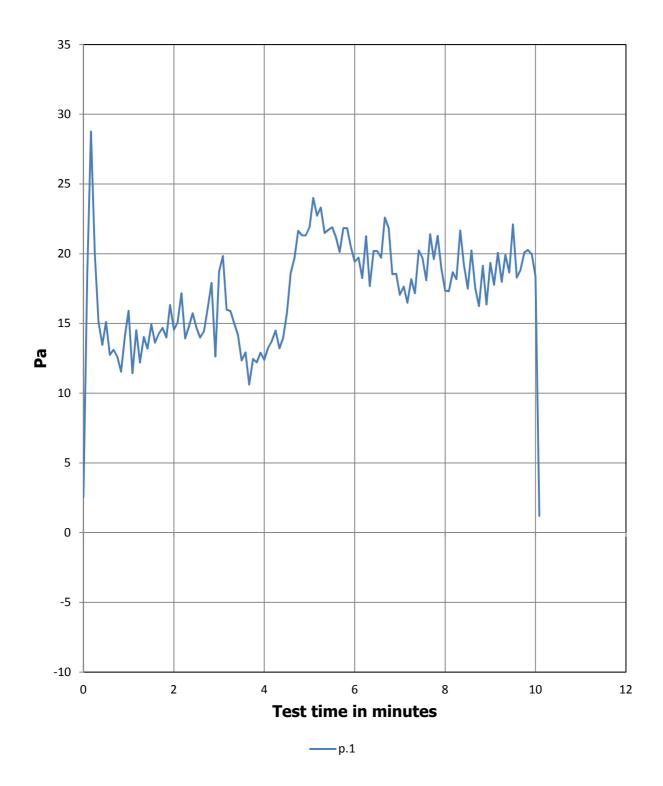
Furnace pressure (test 2)

Enclosures 14.0 and 14.1	Test 2: Furnace pressure measured 100 mm below the test frame.

Min. / Pa	p.1
0.0	2.6
0.5	15.1
1.0	15.9
1.5	14.9
2.0	14.5
2.5	14.7
3.0	18.7
3.5	12.3
4.0	12.4
4.5	15.8
5.0	21.9
5.5	21.9
6.0	19.4
6.5	20.2
7.0	17.0
7.5	19.7
8.0	17.3
8.5	17.5
9.0	19.3
9.5	22.1
10.0	18.4

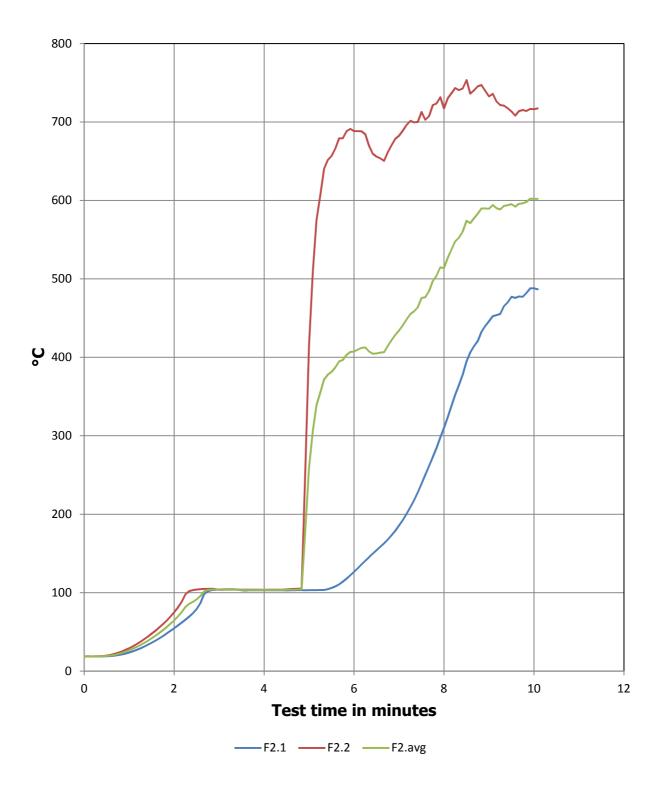
Min. / °C	F2.1	F2.2	F2.Avg
0.0	18.7	18.8	18.8
0.5	18.9	19.7	19.3
1.0	23.7	29.2	26.4
1.5	36.1	47.6	41.9
2.0	54.7	74.8	64.7
2.5	78.9	104.0	91.5
3.0	103.9	103.6	103.8
3.5	103.1	103.7	103.4
4.0	103.0	103.7	103.3
4.5	102.9	104.2	103.6
5.0	103.1	414.4	258.8
5.5	106.1	656.7	381.4
6.0	126.6	688.4	407.5
6.5	154.0	655.8	404.9
7.0	185.4	682.5	434.0
7.5	238.6	712.8	475.7
8.0	310.0	717.3	513.6
8.5	394.9	753.4	574.1
9.0	446.0	732.6	589.3
9.5	477.1	713.3	595.2
10.0	488.0	716.2	602.1

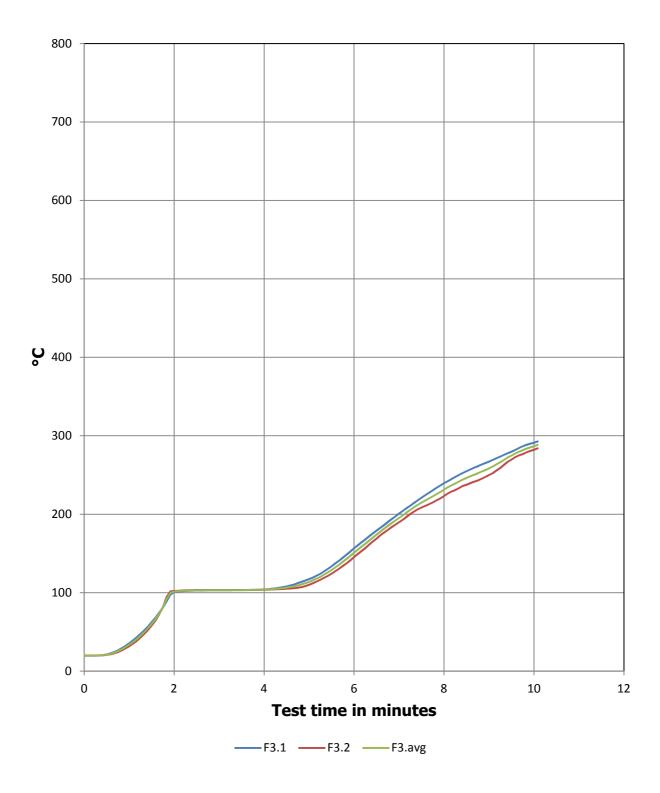
Min. / °C	F3.1	F3.2	F3.Avg
0.0	19.5	20.0	19.8
0.5	21.2	20.7	21.0
1.0	35.4	31.7	33.6
1.5	62.1	58.0	60.1
2.0	100.8	102.1	101.4
2.5	102.8	103.4	103.1
3.0	102.9	103.4	103.2
3.5	103.2	103.4	103.3
4.0	104.2	103.5	103.9
4.5	107.9	105.0	106.5
5.0	117.3	109.9	113.6
5.5	133.6	124.2	128.9
6.0	156.4	145.2	150.8
6.5	179.0	169.0	174.0
7.0	200.6	189.8	195.2
7.5	221.0	208.5	214.8
8.0	239.4	223.1	231.3
8.5	254.7	237.7	246.2
9.0	267.1	249.9	258.5
9.5	279.8	269.7	274.7
10.0	291.2	282.1	286.6

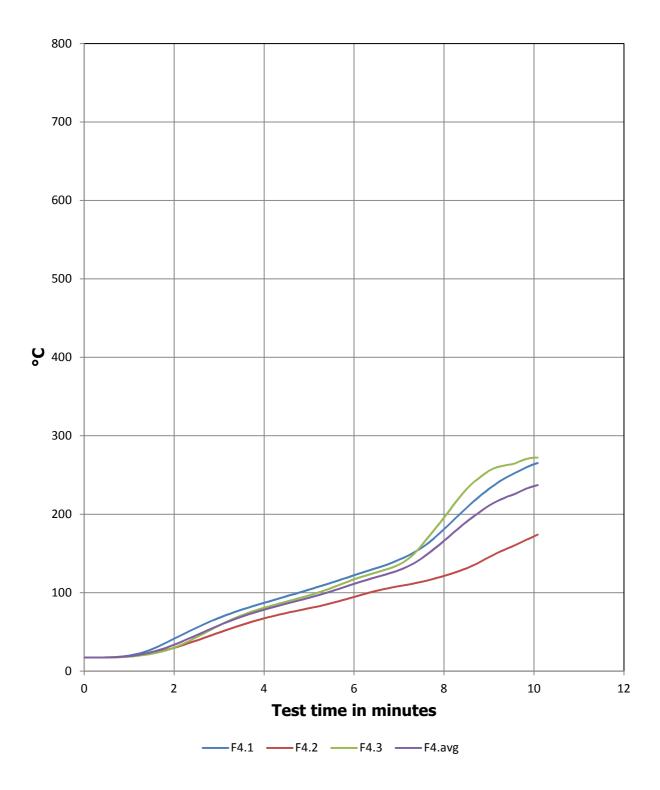
Min. / °C	F4.1	F4.2	F4.3	F4.Avg
0.0	17.3	17.3	17.3	17.3
0.5	17.5	17.4	17.4	17.4
1.0	19.9	18.8	18.4	19.0
1.5	27.8	22.8	22.1	24.2
2.0	41.3	29.6	29.9	33.6
2.5	55.2	39.0	43.2	45.8
3.0	67.9	49.1	58.1	58.4
3.5	78.2	58.8	71.0	69.4
4.0	87.0	67.2	80.7	78.3
4.5	95.4	74.1	88.6	86.0
5.0	103.9	80.1	96.5	93.5
5.5	112.8	86.6	106.0	101.8
6.0	122.1	94.5	117.0	111.2
6.5	131.4	102.4	125.8	119.9
7.0	141.9	108.3	135.6	128.6
7.5	157.1	113.8	160.1	143.7
8.0	180.9	121.4	195.7	166.0
8.5	208.1	131.0	232.0	190.4
9.0	232.3	145.3	255.4	211.0
9.5	250.3	158.6	263.7	224.2
10.0	263.7	171.8	272.1	235.9

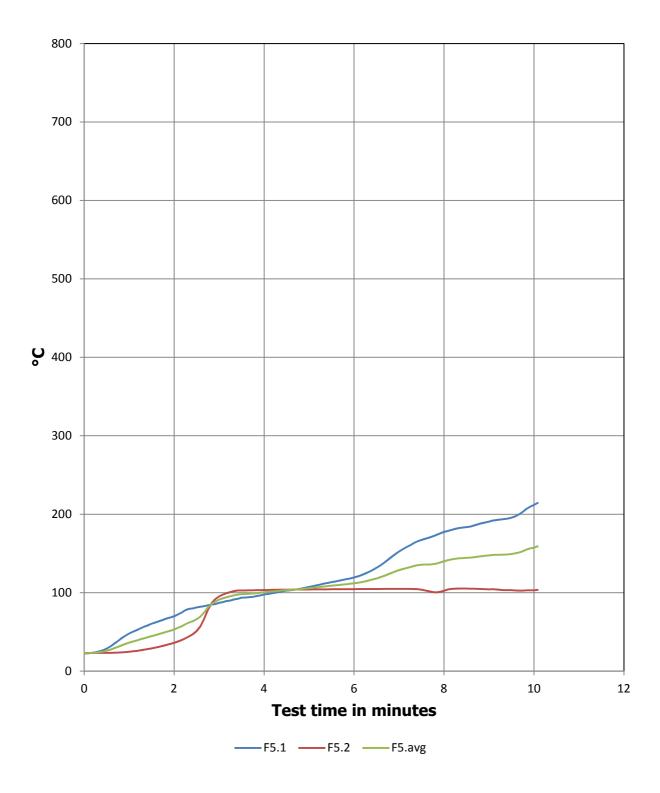
Min. / °C	F5.1	F5.2	F5.Avg
0.0	22.4	23.0	22.7
0.5	28.5	23.2	25.9
1.0	48.0	24.7	36.3
1.5	60.3	29.0	44.7
2.0	69.9	36.2	53.0
2.5	81.2	51.0	66.1
3.0	87.1	95.3	91.2
3.5	93.5	102.8	98.2
4.0	97.6	103.4	100.5
4.5	102.5	103.9	103.2
5.0	107.3	104.1	105.7
5.5	113.4	104.4	108.9
6.0	119.4	104.5	111.9
6.5	131.7	104.6	118.2
7.0	152.4	104.9	128.6
7.5	167.4	103.8	135.6
8.0	177.5	102.3	139.9
8.5	183.5	105.2	144.3
9.0	190.6	104.3	147.5
9.5	195.5	103.1	149.3
10.0	211.8	103.0	157.4

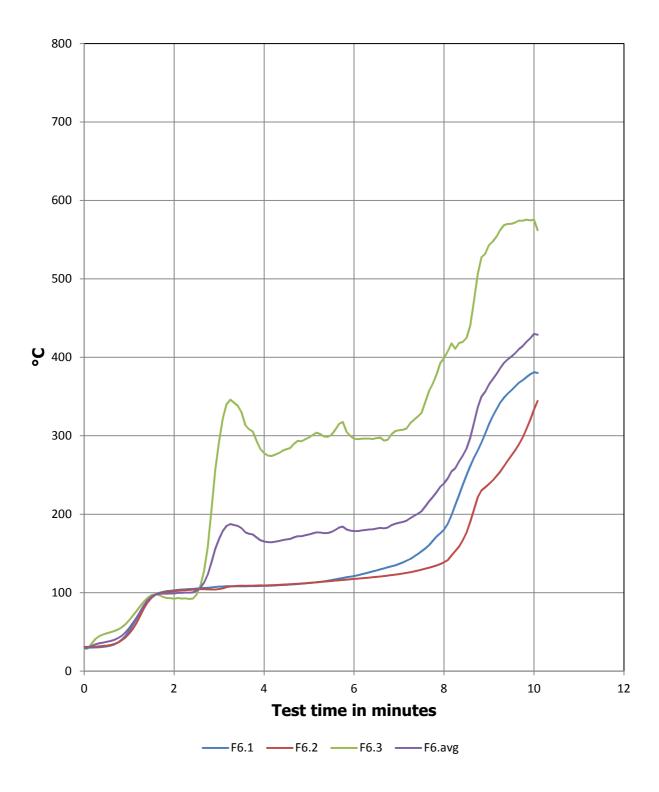
Min. / °C	F6.1	F6.2	F6.3	F6.Avg
0.0	29.8	30.8	28.1	29.5
0.5	31.4	32.5	48.1	37.3
1.0	51.3	47.7	64.8	54.6
1.5	94.7	93.6	96.8	95.1
2.0	103.0	101.7	92.1	98.9
2.5	105.3	104.2	97.5	102.3
3.0	107.8	104.6	293.4	168.6
3.5	108.1	108.9	329.7	182.2
4.0	108.6	109.2	277.8	165.2
4.5	110.0	110.5	282.9	167.8
5.0	112.3	112.4	297.9	174.2
5.5	116.0	114.9	301.2	177.4
6.0	121.2	117.5	296.4	178.4
6.5	128.4	120.1	297.0	181.8
7.0	136.7	123.6	307.0	189.1
7.5	152.8	129.3	329.3	203.8
8.0	180.3	138.7	398.9	239.3
8.5	249.8	176.6	424.7	283.7
9.0	314.8	238.4	543.1	365.4
9.5	358.3	274.9	570.2	401.2
10.0	381.0	333.3	575.4	429.9

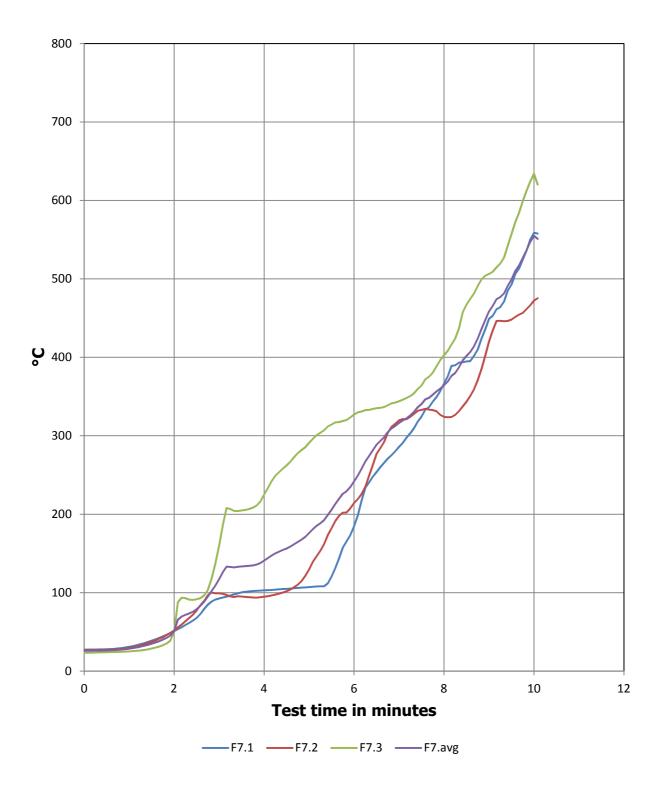
Min. / °C	F7.1	F7.2	F7.3	F7.Avg
0.0	27.4	26.7	23.3	25.8
0.5	27.9	27.1	24.1	26.3
1.0	30.9	29.6	25.1	28.6
1.5	38.7	37.3	28.7	34.9
2.0	50.9	52.0	49.8	50.9
2.5	67.8	77.2	91.6	78.8
3.0	92.6	99.0	160.2	117.3
3.5	100.3	95.1	204.8	133.4
4.0	102.9	94.8	225.3	141.0
4.5	104.9	101.8	262.1	156.3
5.0	107.0	129.3	290.9	175.7
5.5	120.6	182.2	314.4	205.7
6.0	184.2	214.1	327.1	241.8
6.5	253.9	277.0	335.1	288.7
7.0	285.9	319.7	343.9	316.5
7.5	324.6	332.9	364.1	340.5
8.0	366.7	324.1	402.5	364.4
8.5	394.7	343.4	467.3	401.8
9.0	449.0	420.0	506.0	458.3
9.5	492.8	448.2	557.4	499.5
10.0	558.7	472.2	634.0	555.0

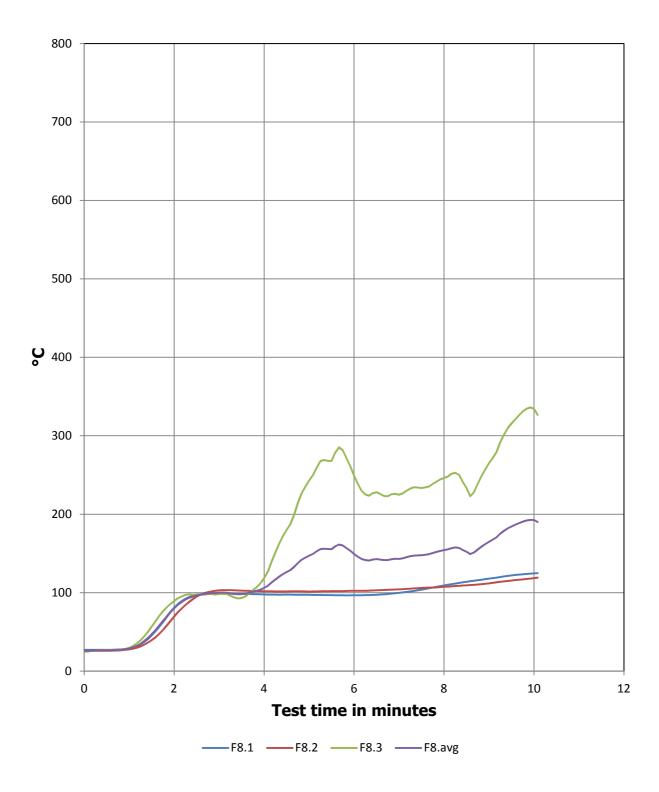
Min. / °C	F8.1	F8.2	F8.3	F8.Avg
0.0	27.0	25.7	24.7	25.8
0.5	27.2	25.9	26.7	26.6
1.0	28.8	27.7	29.8	28.8
1.5	45.3	39.3	56.4	47.0
2.0	80.9	69.6	89.3	79.9
2.5	96.8	94.9	97.6	96.4
3.0	98.4	103.1	98.3	99.9
3.5	98.3	102.6	93.2	98.1
4.0	97.7	101.9	118.6	106.1
4.5	97.5	101.5	179.9	126.3
5.0	97.3	101.4	242.7	147.1
5.5	96.8	101.9	267.8	155.5
6.0	96.6	102.3	249.3	149.4
6.5	97.3	103.0	228.1	142.8
7.0	99.7	104.3	224.8	142.9
7.5	103.8	106.0	233.3	147.7
8.0	109.2	107.5	246.2	154.3
8.5	113.9	109.4	233.4	152.2
9.0	117.9	111.8	265.0	164.9
9.5	122.0	115.4	315.9	184.4
10.0	124.6	118.6	334.3	192.5

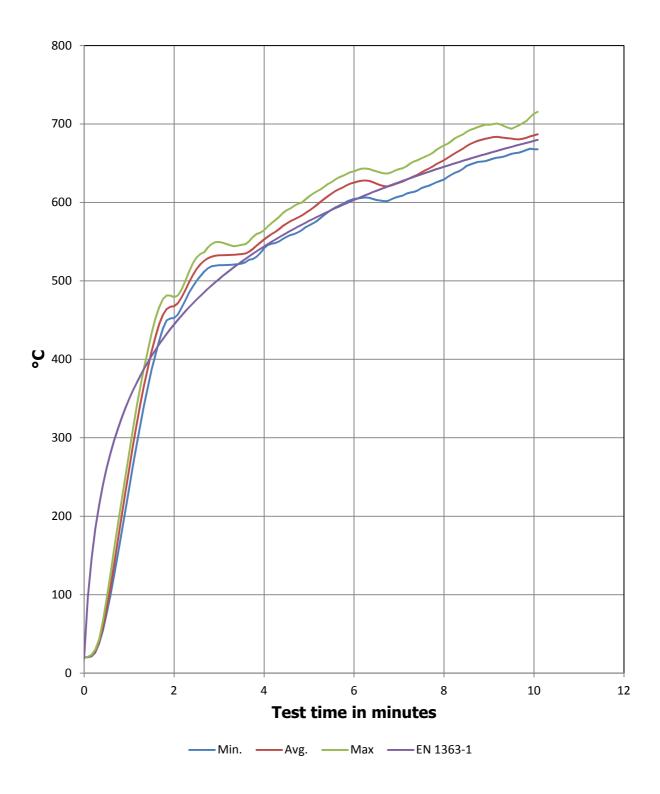
Furnace temperature (test 1)

Time	Measured			Norm	Area unde	r curve		
Minutes	Minimum	Average	Maximum	EN 1363-1	Measured	EN 1363-1	Dev. [%]	Limit [%]
0.0	20.0	20.2	20.4	20.0	0	0	#DIV/0!

0.5	75.5	81.1	94.3	261.1	18	85	-78.5	
1.0	235.4	259.7	280.4	349.2	103	240	-57.1	
1.5	386.8	410.1	433.0	404.3	273	429	-36.4	
2.0	452.6	467.8	479.2	444.5	498	642	-22.4

2.5	499.9	515.1	529.9	476.2	743	872	-14.9	
3.0	520.0	532.6	549.7	502.3	1006	1117	-9.9	
3.5	522.1	534.0	545.9	524.5	1273	1374	-7.4	
4.0	541.5	552.7	564.6	543.9	1544	1641	-5.9

4.5	556.0	573.1	589.9	561.0	1825	1917	-4.8	
5.0	570.6	589.4	607.5	576.4	2115	2202	-3.9	
5.5	590.8	611.2	626.0	590.4	2416	2494	-3.1	15.0
6.0	604.5	625.3	639.6	603.1	2725	2792	-2.4	15.0

6.5	603.0	623.8	639.5	614.9	3039	3096	-1.9	15.0
7.0	607.5	625.1	642.3	625.8	3350	3407	-1.7	15.0
7.5	618.4	638.4	656.2	635.9	3665	3722	-1.5	15.0
8.0	629.1	653.8	672.5	645.5	3988	4042	-1.3	15.0

8.5	646.6	671.8	689.8	654.4	4320	4367	-1.1	15.0
9.0	654.1	682.0	699.0	662.8	4659	4697	-0.8	15.0
9.5	662.0	681.3	693.8	670.8	5000	5030	-0.6	15.0
10.0	667.8	685.5	713.2	678.4	5341	5368	-0.5	15.0
