Nye løsninger til fremtidens infrastrukturer

Bridge Inspections with Drones

Limfjord Tunnel

Assessment and retrofitting

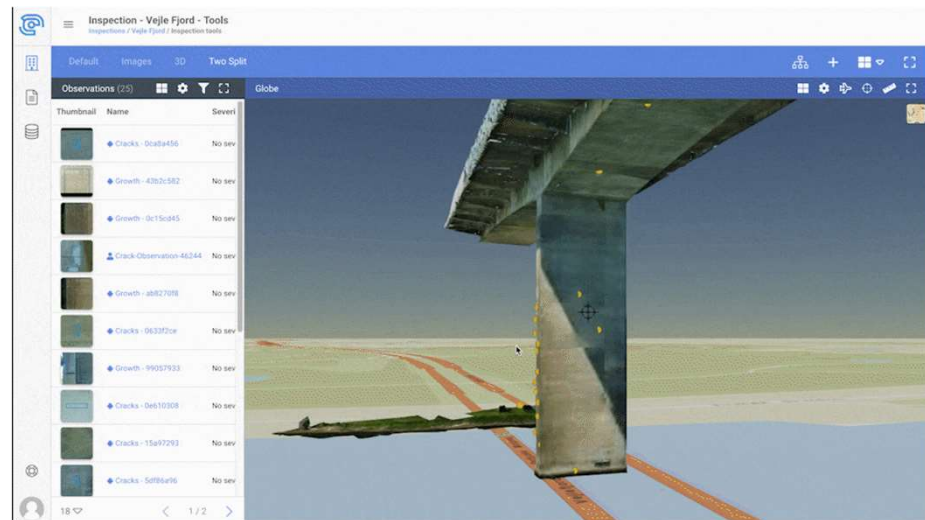
An exact representation of the existing structure that you'll be renovating.

Information on the detected damages visibly marked in the 3D model.

The 3D BIM model helps making informed decisions based on complete visibility.

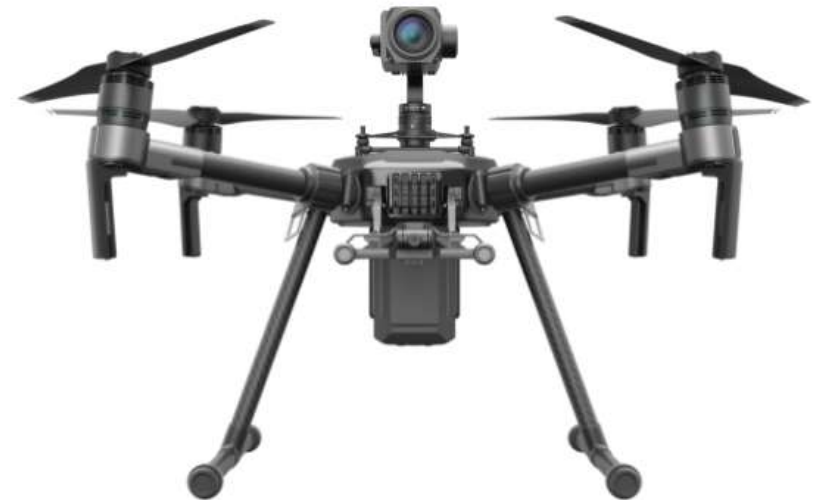
Data quality

To collect data with a satisfactory quality, it requires a good camera on the drone, which also must have the opportunity to photograph upwards to cover upwards surfaces.

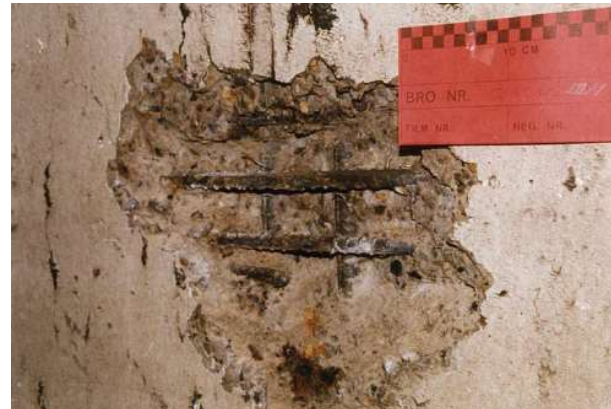
The Limfjord Tunnel completed in 1969.

- Water-proofing membrane.
- Cracks in the tunnel roof and outer walls.
- Settlements of the tunnel.
- Corrosion of the reinforcement.
- Post-tensioning cables installed in 1993-94.
- Reinforcement and concrete repair late 1990's.
- Anchors repair due to delamination in 2010.
